TWR-18898

Qualification of the RSRM Case Membrane Case-to-Insulation Bondline Inspection Using the Thiokol Corporation Ultrasonic RSRM Bondline Inspection System

Final Test Report

April 1990

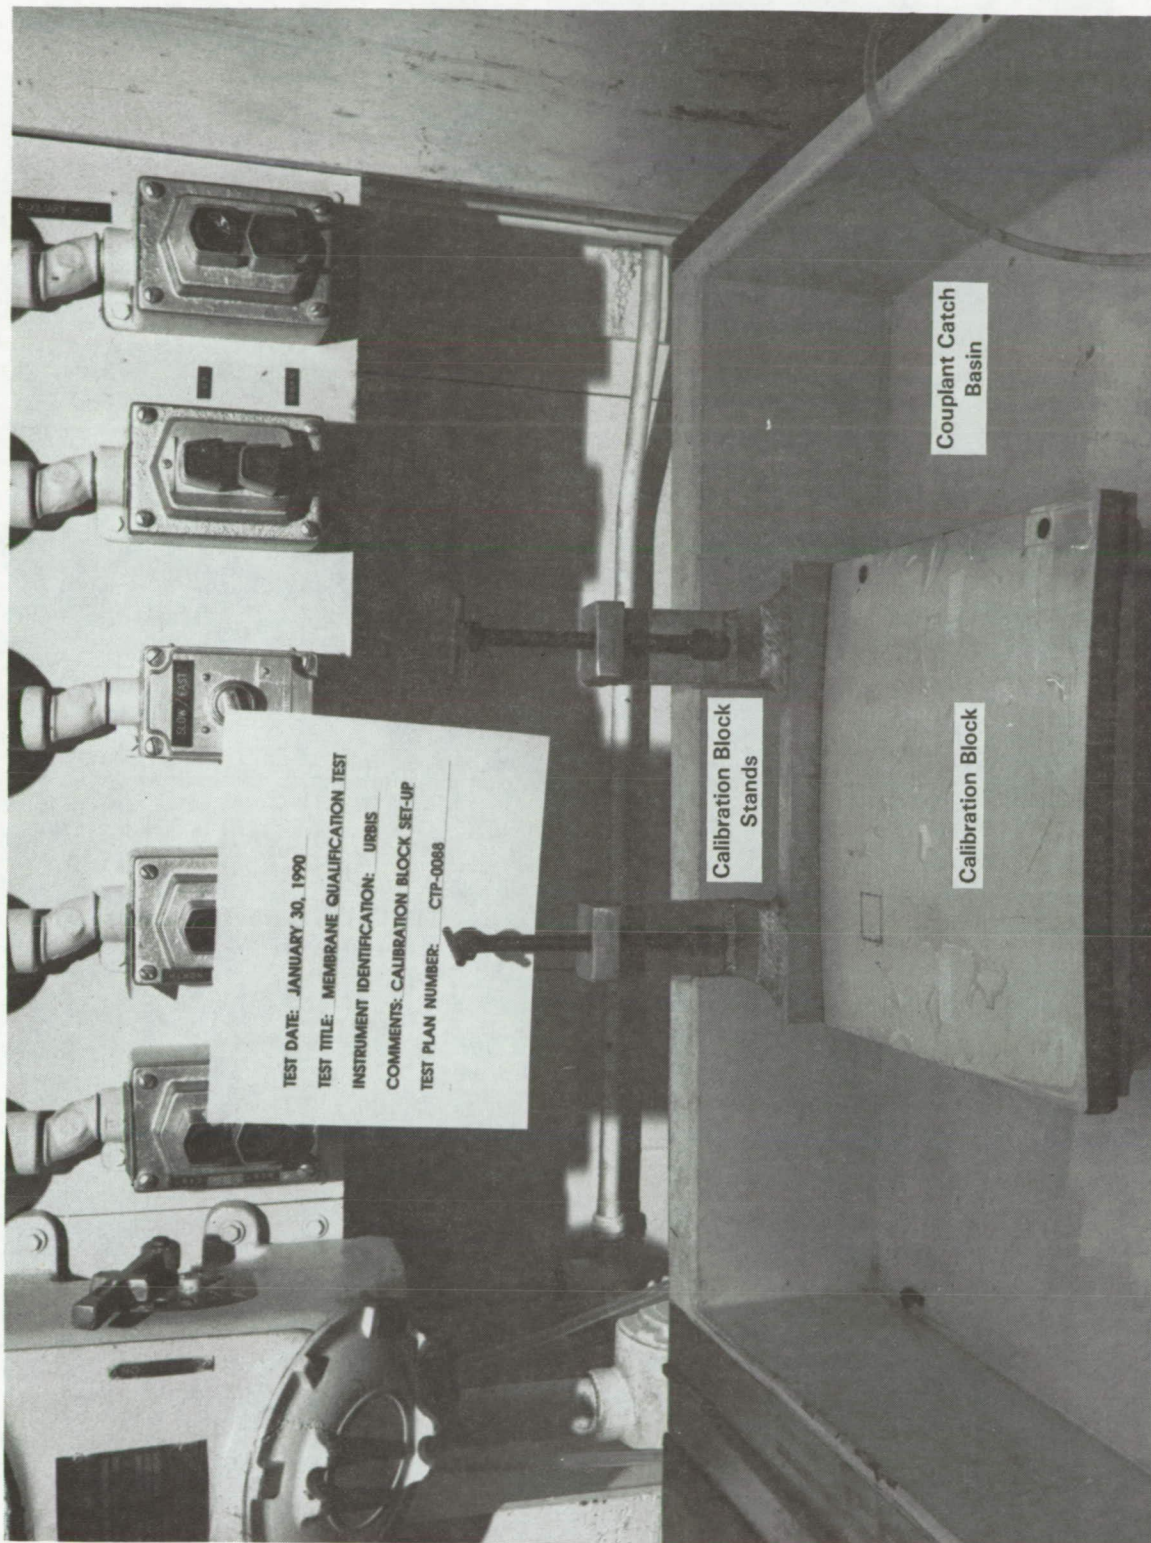
Figure 4. Calibration Block Setup

1. The case membrane scanner and the inspection technique were calibrated on the ultrasonic calibration standard (P/N 2U129702), which contained an intentional 1.0 by 1.0-in. case-to-insulation unbond. This calibration, known as "calibration in," enabled operators to clearly distinguish the 1.0 by 1.0-in. unbond from the bonded regions.
